HOUSATONIC RIVER BASIN
DERBY, CONNECTICUT

LOWER ANSONIA RESERVOIR DAM CT 00027

PHASE I INSPECTION REPORT NATIONAL DAM INSPECTION PROGRAM

SEPTEMBER, 1980

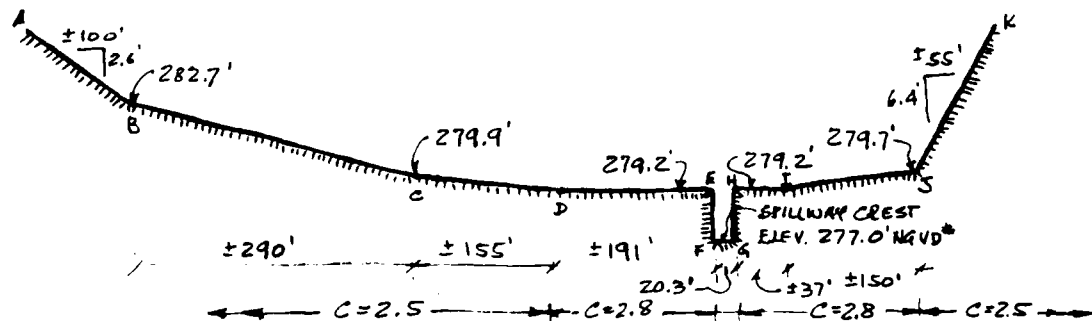
LOWER ANSONIA RESERVOIR DAM
APPROXIMATE OVERFLOW PROFILE

DATA FROM THE ANSONIA WATER CO. Dwg. "PLAN AND ELEVATIONS OF DAM AT THE LOWER RESERVOIR OF THE BIRMINGHAM WATER CO." AND C.E. OBSERVATIONS ON 5/28/80 BY WLL & R.S.

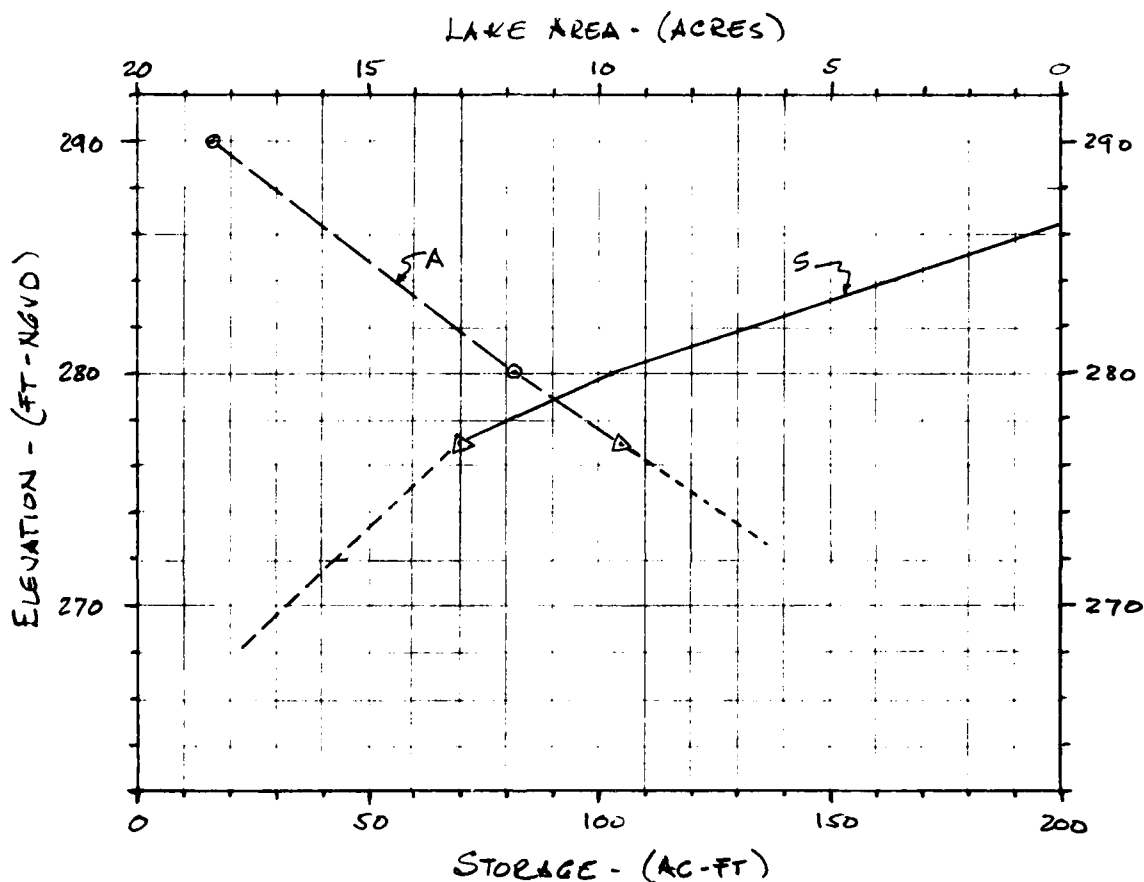
A) RESERVOIR AREA/STORAGE CURVES - LOWER ANSONIA RESERVOIR

Δ DATA FROM ANSONIA WATER CO. DWA. "RESERVOIR N°1" (FILE N° 276T-27-FF1)

○ AREAS FROM USGS ANSONIA, CT. QUADRANGLE SHEET (REV. 1972)
